NATIONAL BUREAU OF STANDARDS REPORT

QUARTERLY STATUS REPORT FOR THE
QUARTER ENDING APRIL 30, 1966 ON

INVESTIGATION OF THE DIRECTIONAL EFFECTS
IN THE STRESS CORROSION OF ALUMINUM ALLOYS

Contract H-2151A
Control 1-6-54-01046-01 (1F)

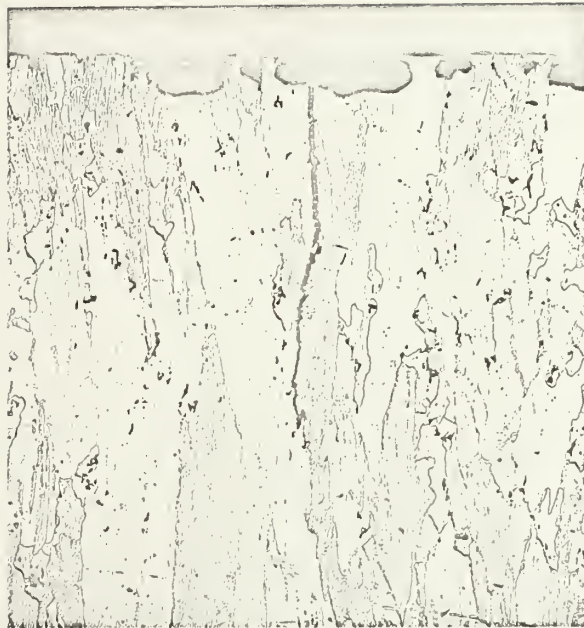
Figure 3

Photomicrograph of a 7075-T651 aluminum alloy short transverse specimen which failed at 75% of its yield strength after 5 minutes in Alcoa H solution. Note the intergranular stress-corrosion cracks which start at the pits. Keller's etch X 100

All tests were made using 75% of the specimen's yield strength. Times to failure for the 7075-T651 alloy were 5 minutes for the short transverse, 5.5 hours for the long transverse and 10.6 hours for the longitudinal specimens. (Preliminary tests - only one specimen tested in each orientation.) Photomicrographs (Figures 3, 4 and 5) were taken of the short transverse specimens and show the typical stress-corrosion cracks observed. The fractured surfaces are being replicated for electron microscopy studies. Work is continuing to determine if the long transverse and longitudinal specimens failed by stress-corrosion.

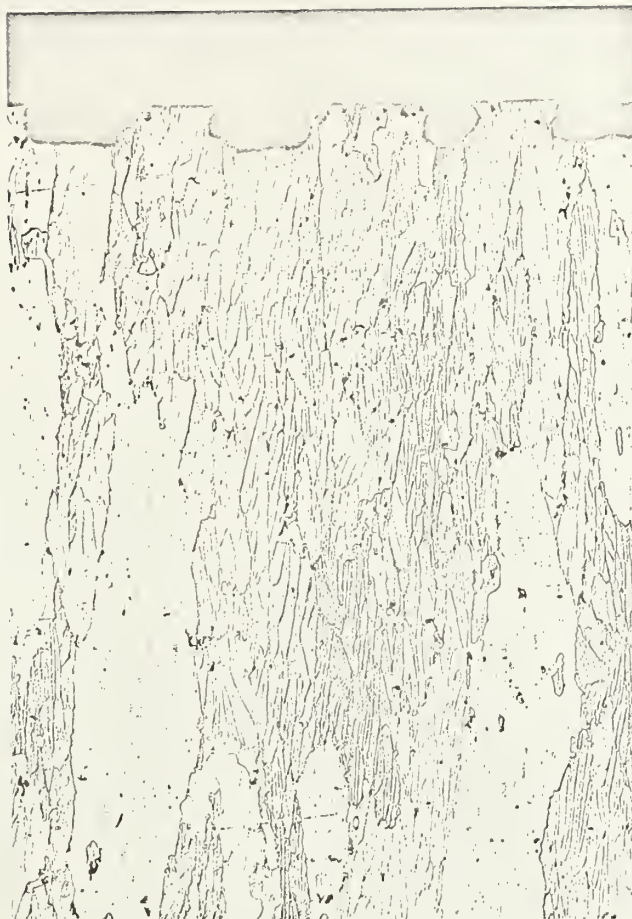
Figure 5

Photomicrograph of a 7075-T651 aluminum alloy short transverse specimen which failed at 75% of its yield strength after 5 minutes in Alcoa H solution. Note the intergranular stress-corrosion cracks which start at the pits. Compare with the unetched condition in Figure 4. Keller's etch X 100
